**IMPACT RESISTANCE OF  
COMPOSITE FAN BLADES**

**E. J. PREMONT  
K. R. STUBENRAUCH**

**PRATT & WHITNEY AIRCRAFT  
DIVISION OF UNITED AIRCRAFT CORPORATION**

**CONTRACT NAS3-16763**

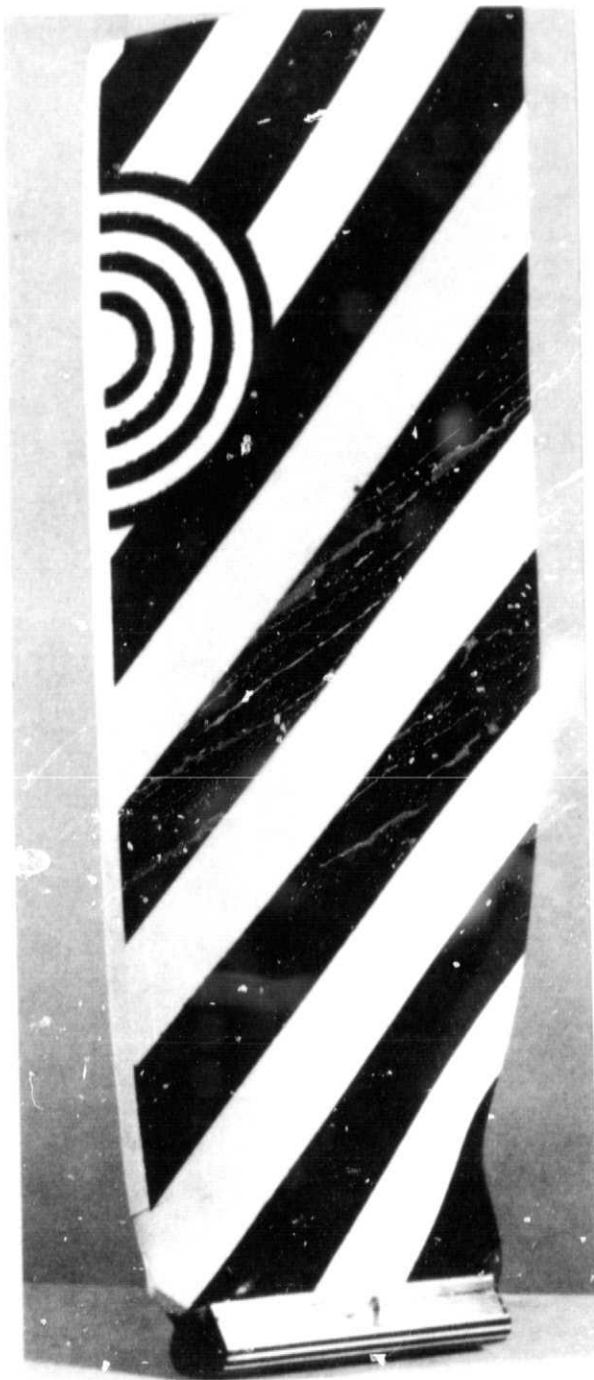
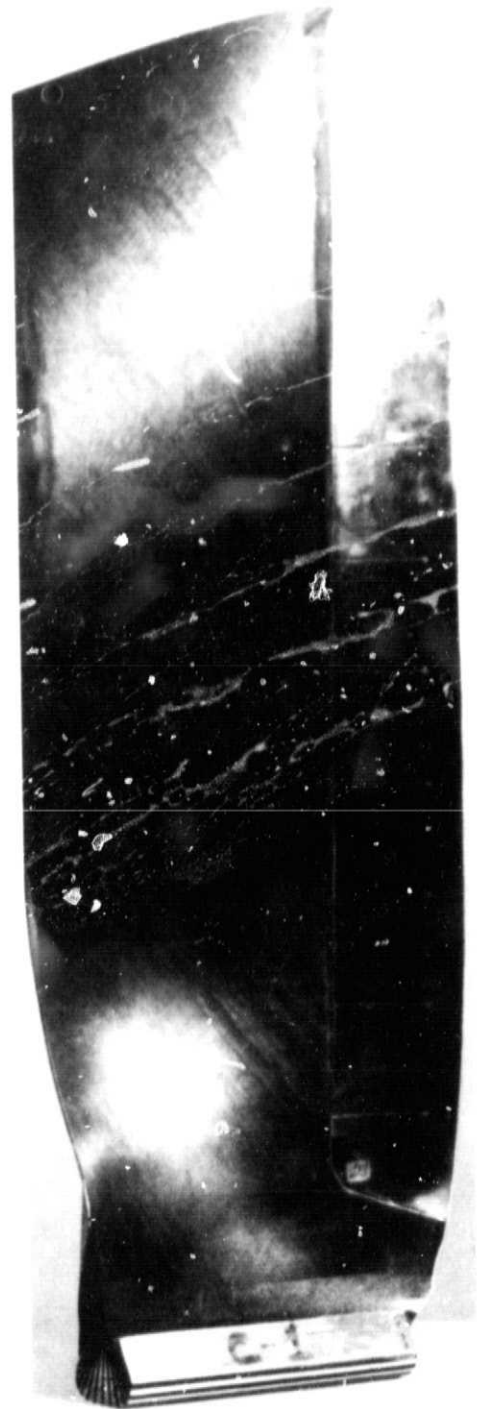
Figure 25 Graphite/Epoxy Blade C-1 Following Impact with Ice Ball

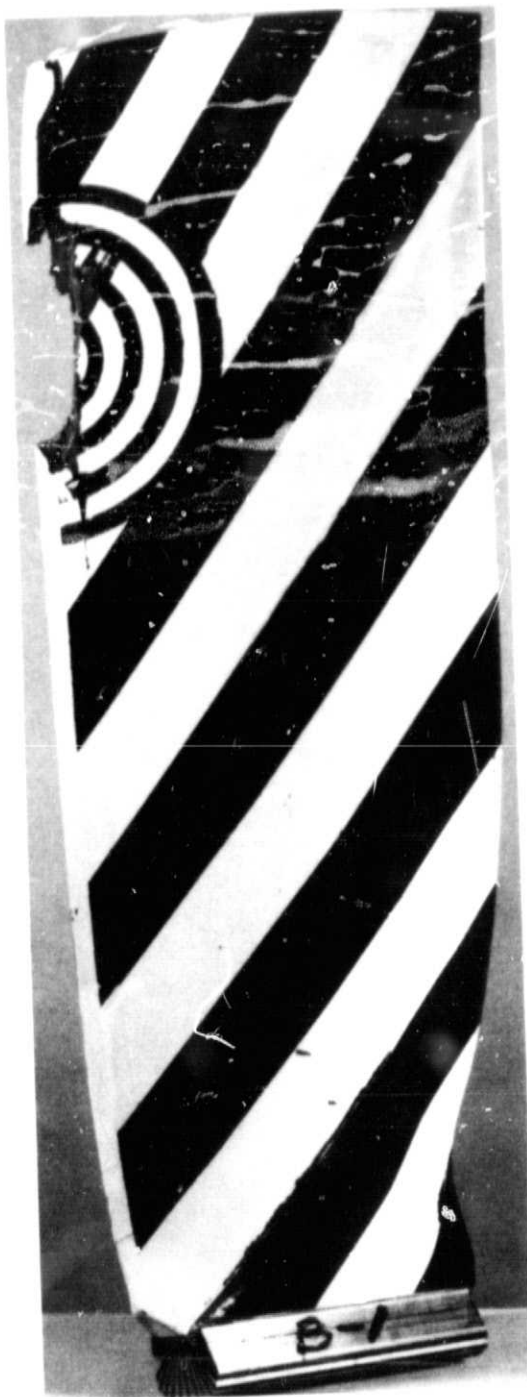
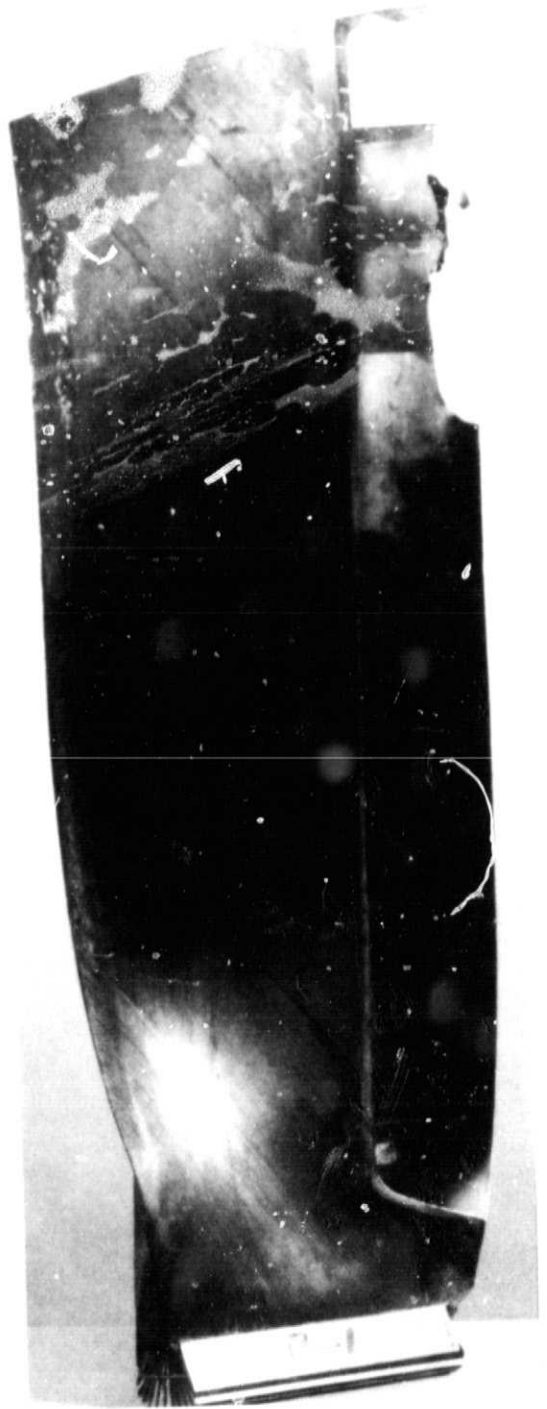
Figure 26 Boron/Epoxy Blade B-1 Following Impact with Ice Ball
